Agnes Water / Seventeen Seventy– Shoreline Erosion Management Plan

Purpose of the SEMP/Objectives

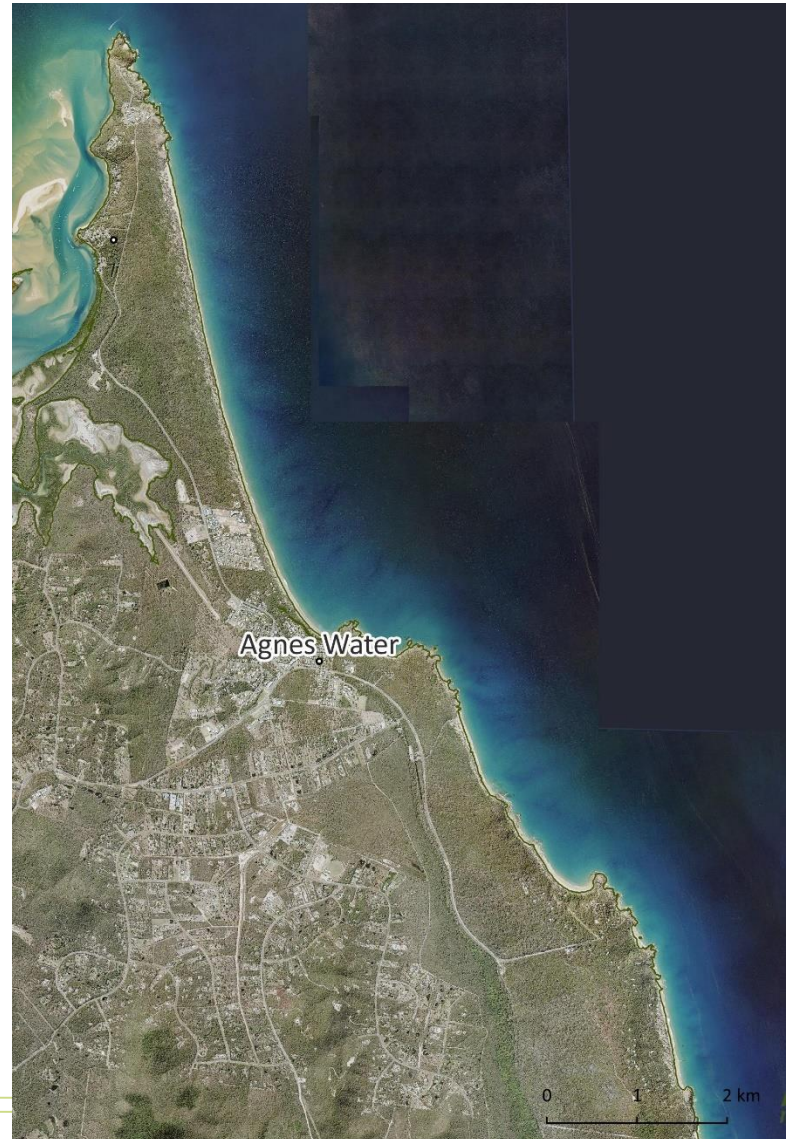
○ Landscape setting

Parabolic dunes

- sand builds up in arcs over underlying rock

Grasses, vines small shrubs and trees along the dunes

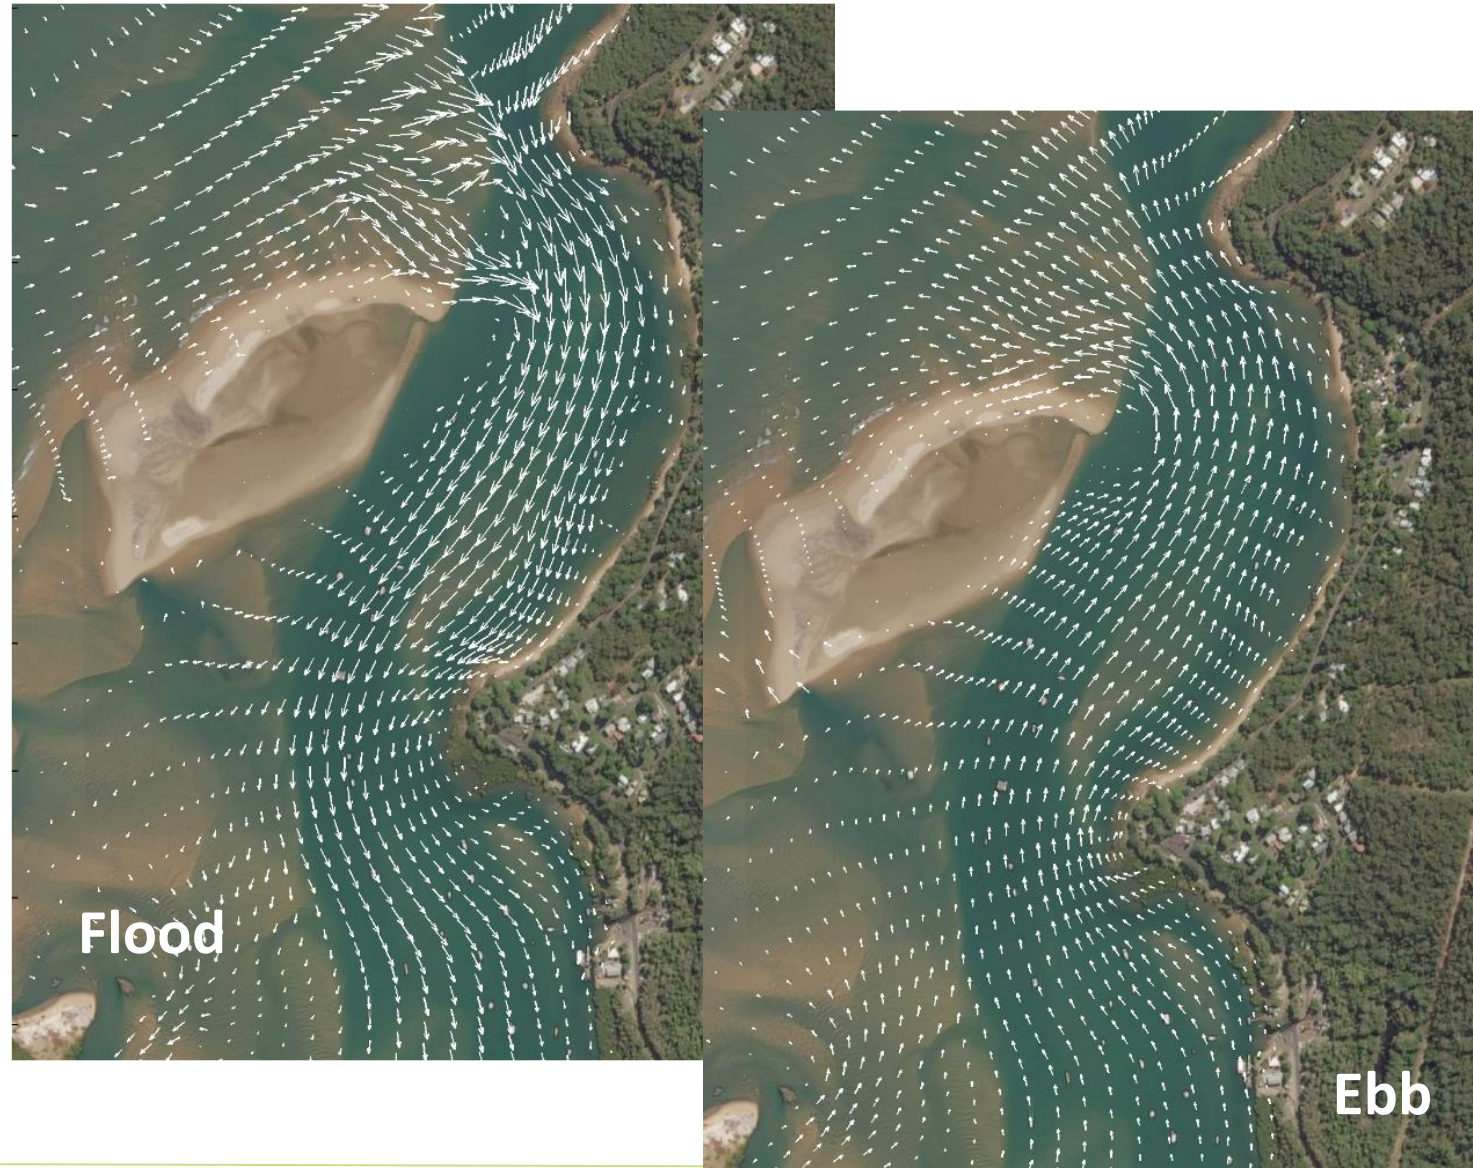
○ Coastal processes

SEVENTEEN SEVENTY

Tides and currents are a dominant driver of change

~3m tidal range, semi diurnal

Stronger currents on the flood tide

Currents (esp. ebb tide) influencing shoreline dynamics

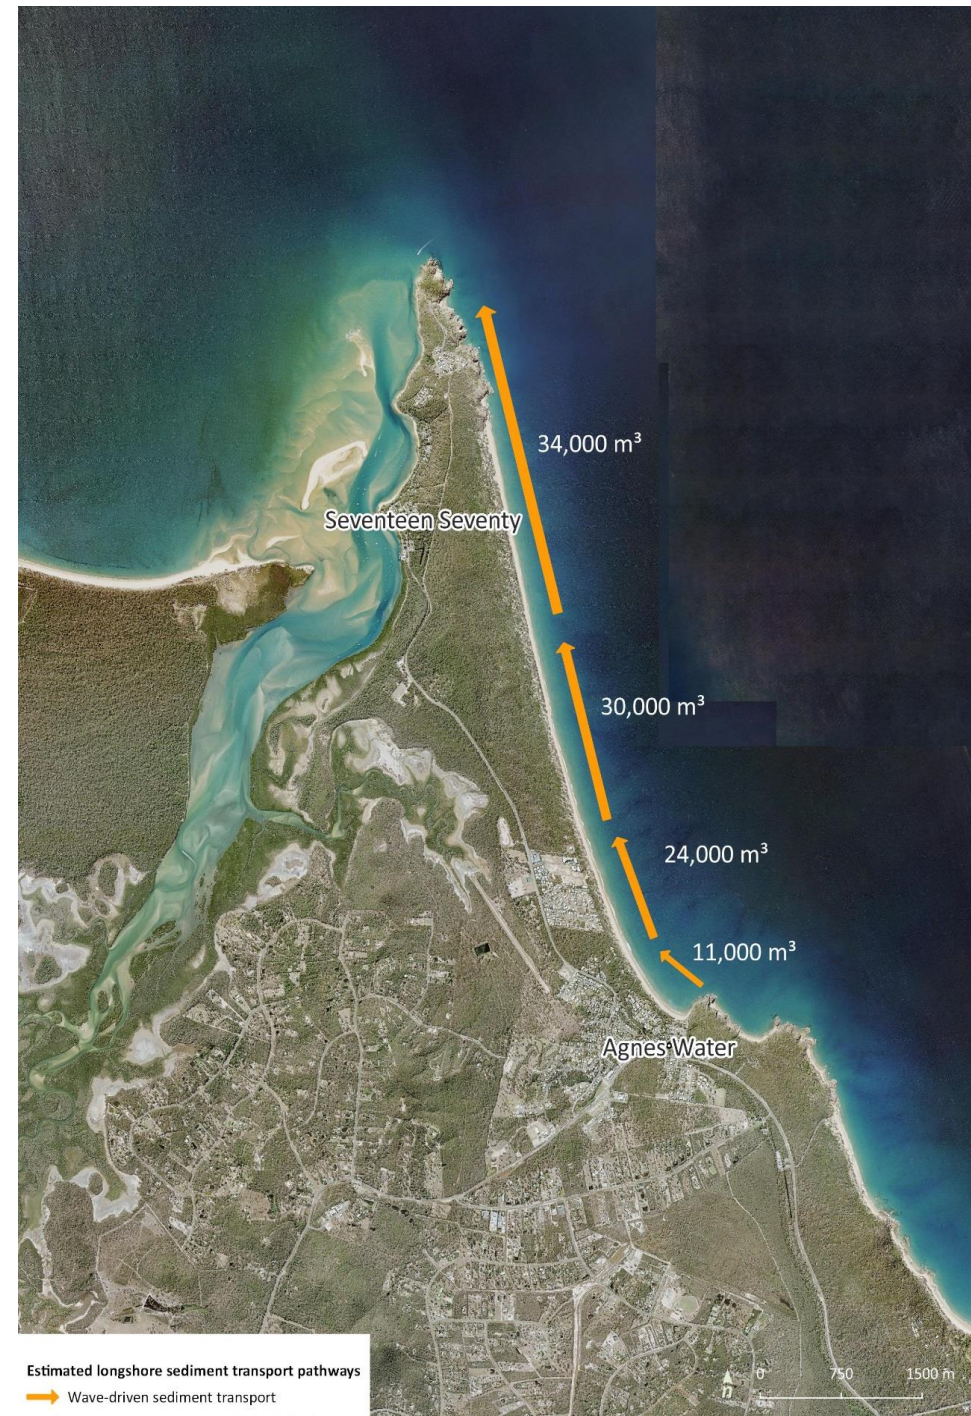
○ Coastal processes

AGNES WATER

- Waves are a driver of change
- Longshore sediment transport regime driven by wave action
 - waves break at an angle to the shore – “push it along’
- Dominant northerly direction

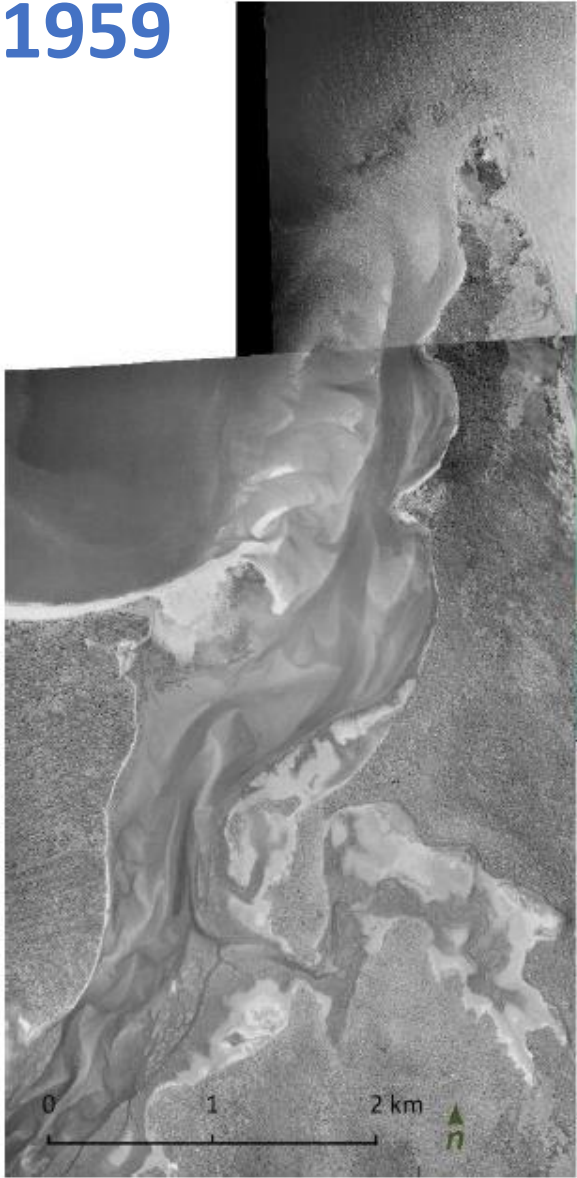
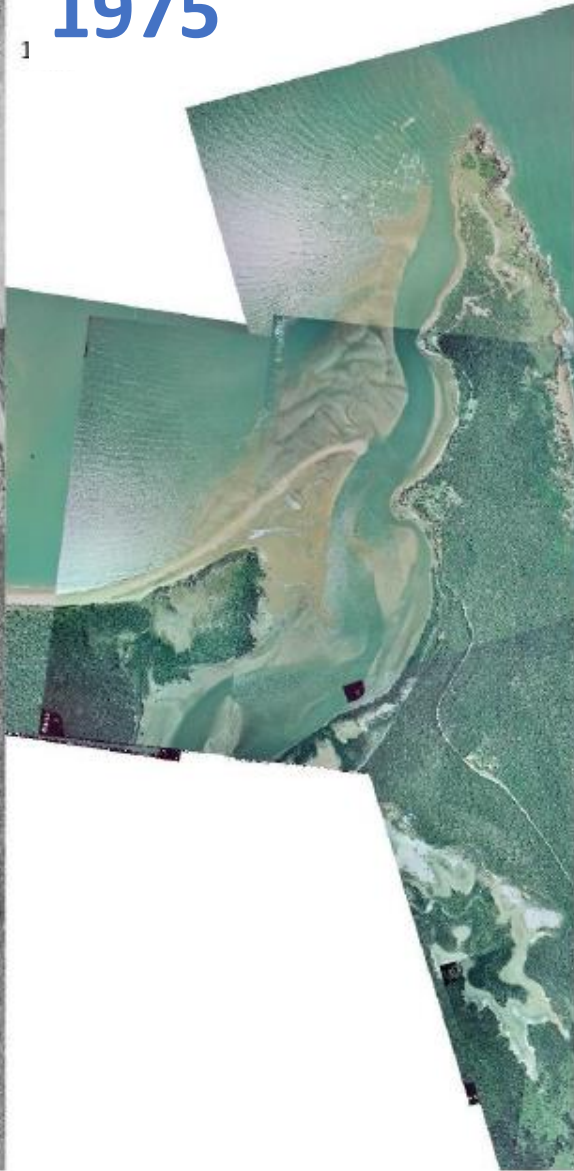
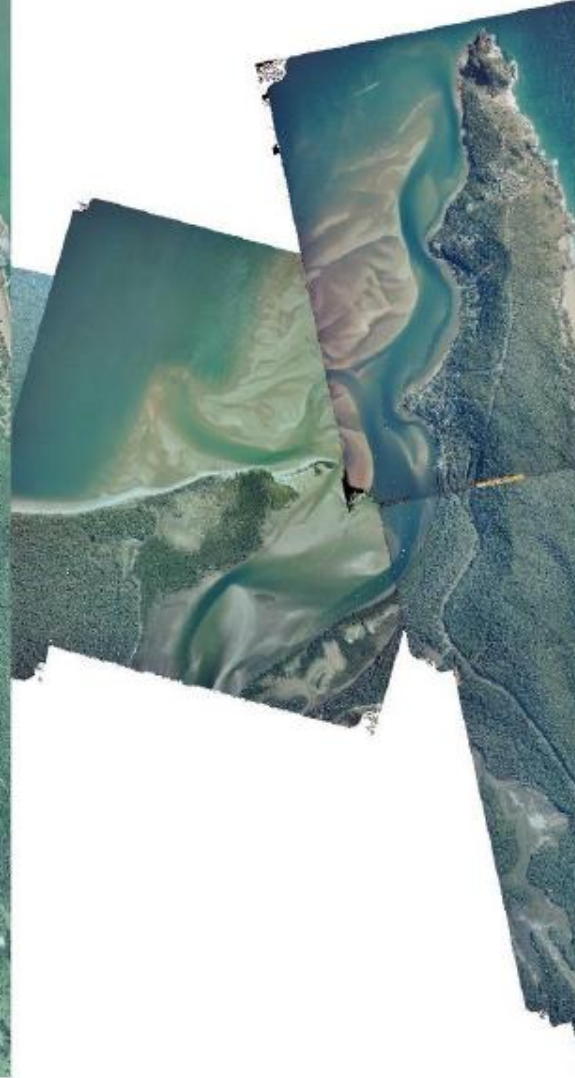
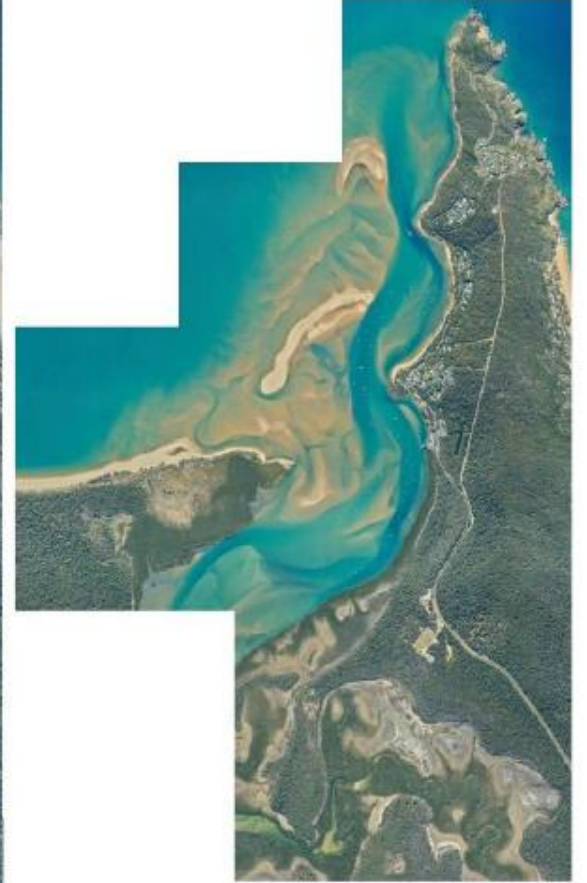
Figure 16. Historical aerial imagery for Seventeen Seventy (1959 to 2018)

○ Trends in shoreline changes – historical imagery

Observations from 1959 to 2018 include:

- Broader coastline is relatively stable over recent decades
- Regular shifting of tidal channels, sand banks and shoals at the mouth of Round Hill Creek estuary and adjacent to the Seventeen Seventy shoreline
 - linked to dynamic process and likely dredging operations as well
- No major sediment losses/gains along coastline north and south of Agnes Water
- Road and residential development commencing from early 1970s, and expanding to present day extents.

○ Shoreline changes – Seventeen Seventy

- localised recession at northern extent of Seventeen Seventy shoreline – Captain Cook Drive runs close to coast.
- shoreline recession at Seventeen Seventy slowed from 1975 onwards, and shoreline has been in a relatively stable position since 2001.

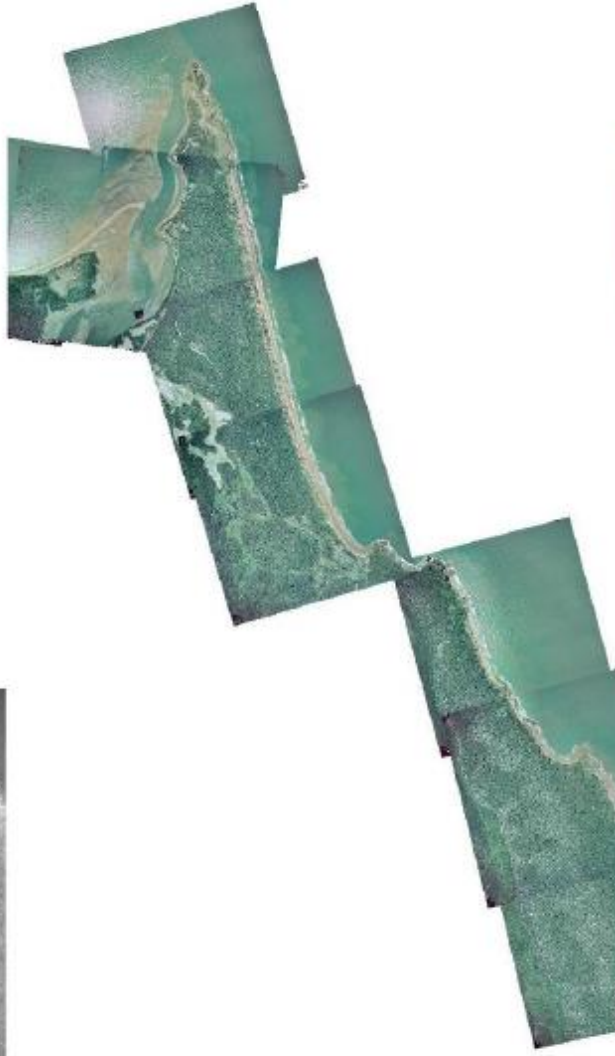
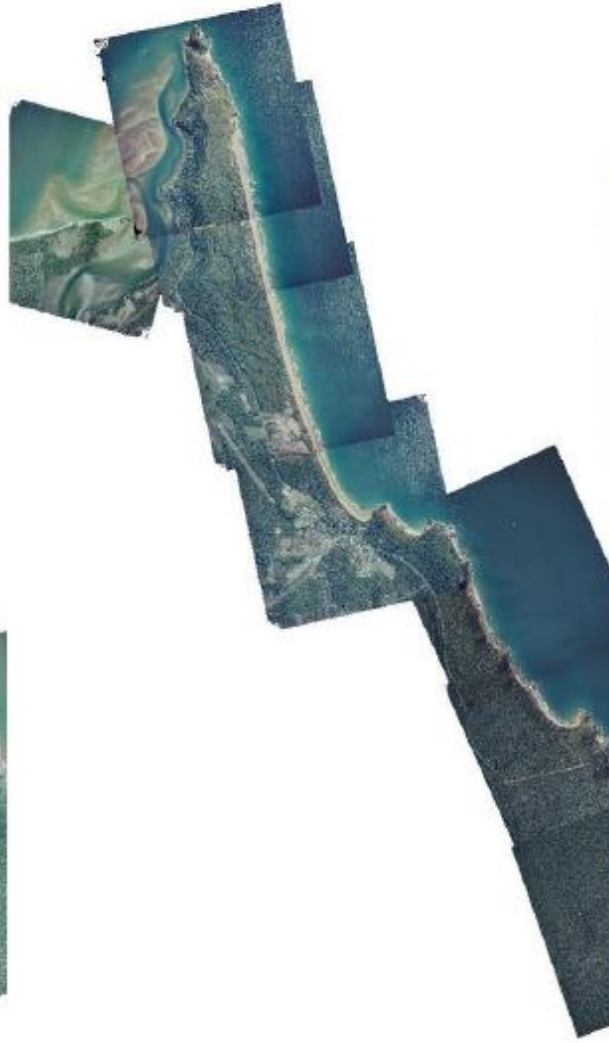
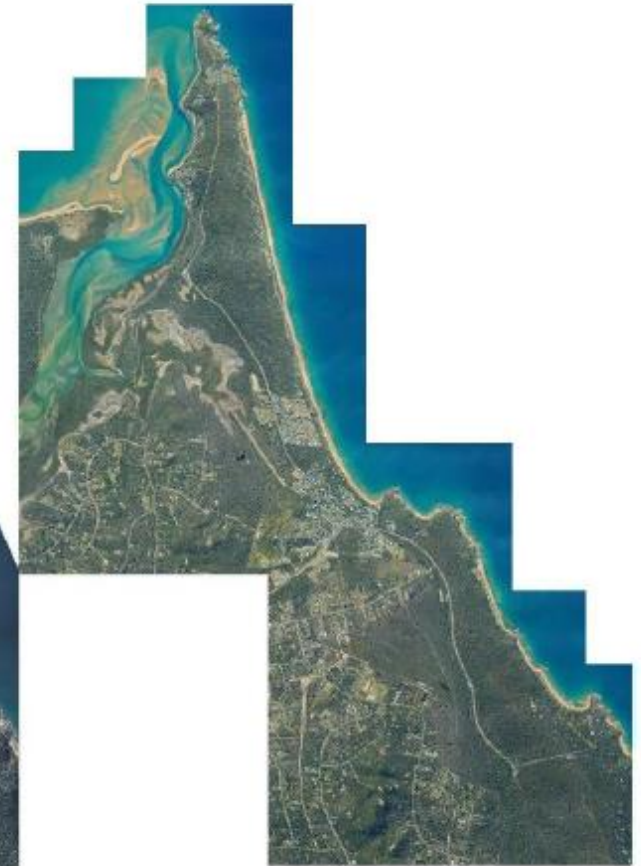
1959

1975

2001

2018

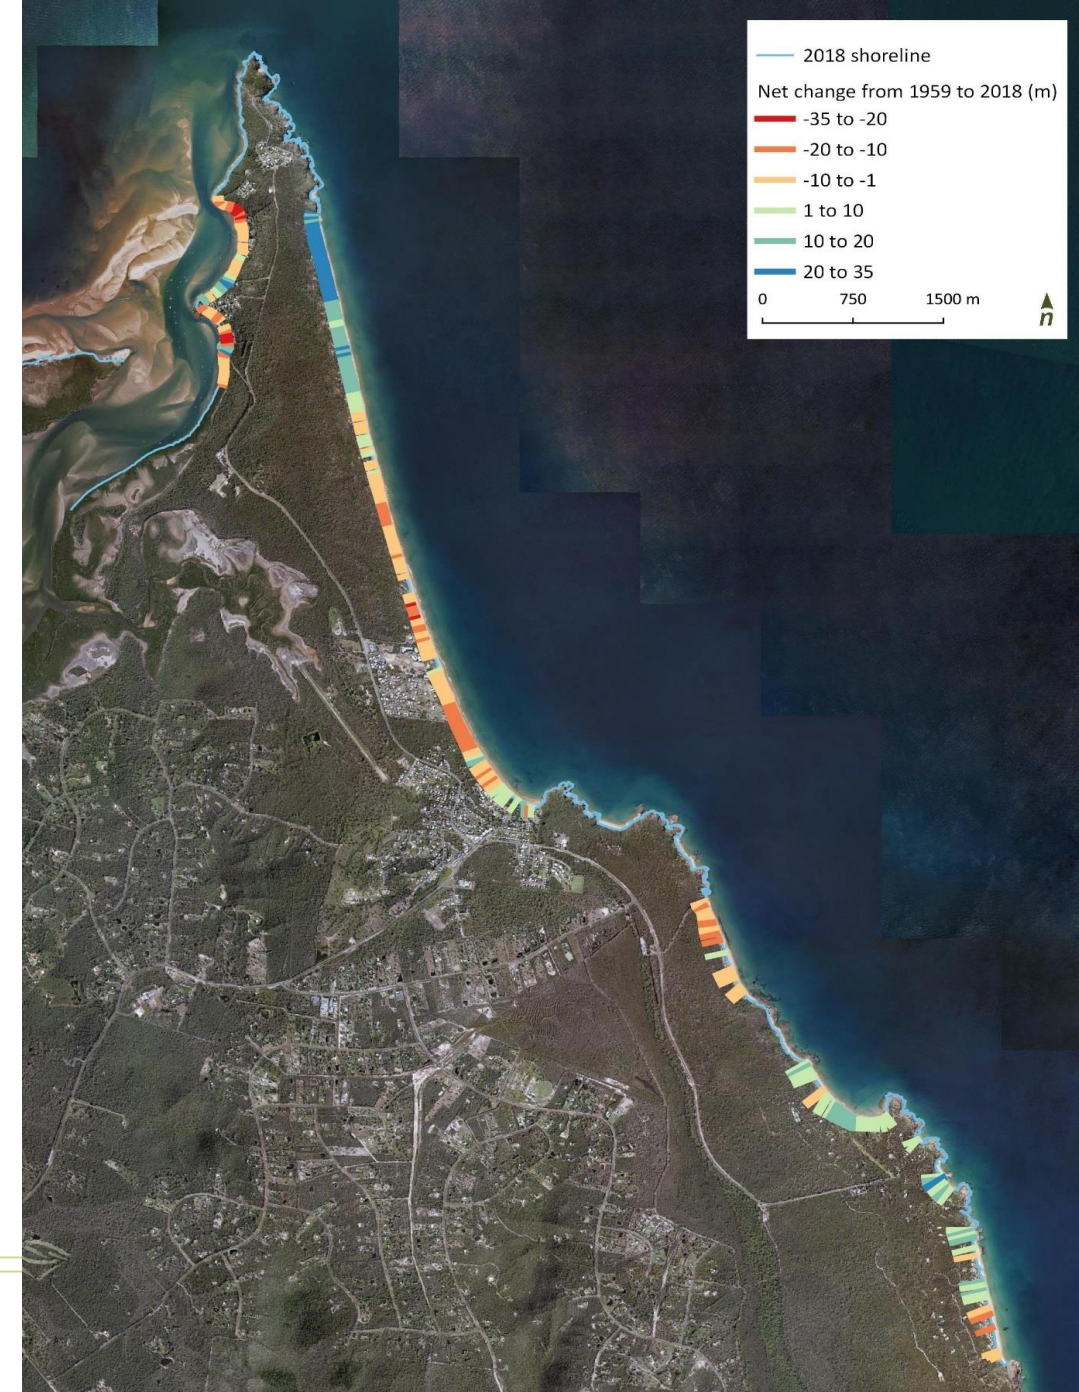
○ Shoreline changes – Agnes Water

- moderate incremental recession at the southern end of the Agnes Water coastline,
- accretion further north towards Round Head headland.
- variable pockets of accretion and recession along the sandy pocket beaches of the rocky coastline to south of Agnes Water.

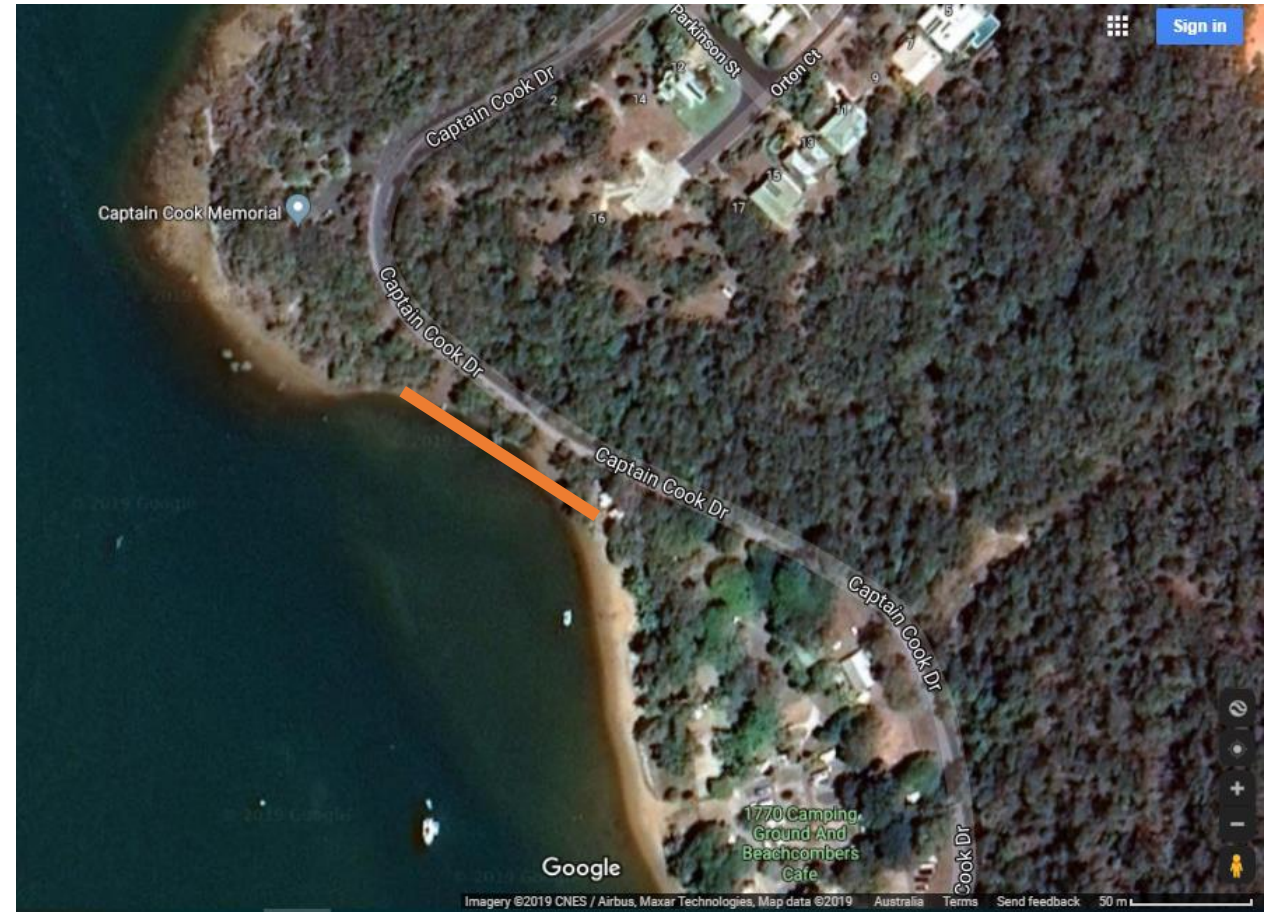
SITE 1 : Captain Cook Drive

Road is main/last access road to Round Hill headland

Considered a “critical asset”

Recommendations :

Properly designed revetment protection

~150 m

Rock material – design life

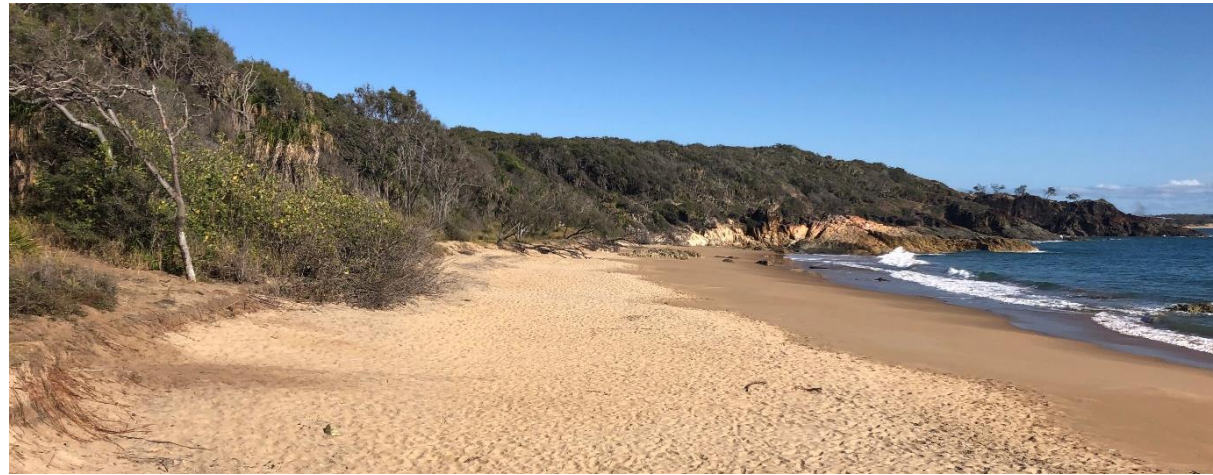
Part C – North and south of Agnes Water

- Dune protection and maintenance
 - enhance dune building/accretion and recovery after storm events, including minimising disturbance, revegetation, sand fencing.
- Ensuring geobags and desal infrastructure remain buried (post-storm sand scraping).
